**Missouri Department of Natural Resources
Water Protection Program**

Total Maximum Daily Load (TMDL)

Shibboleth Creek

Total Maximum Daily Load (TMDL)
Shibboleth Branch
Pollutant: Inorganic Sediment

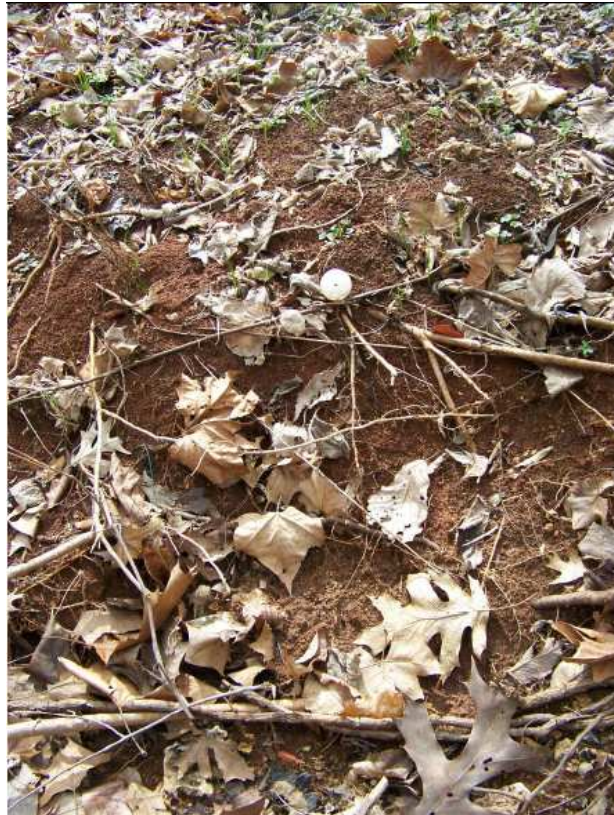
Figure 2. Shibboleth Branch streambank approximately 0.6 miles downstream of Bottom Diggins Dam illustrating “Tiff Soil Series,” with wiffle golf ball for scale (photograph taken March 23, 2009).
